WESLEY'S, 4 CHURCH STREET, WOLVERTON MK12 5JN (REF: PRD2013)

Report: compiled by Andrew & Shaaron Forbes, Pastors King's Church MK

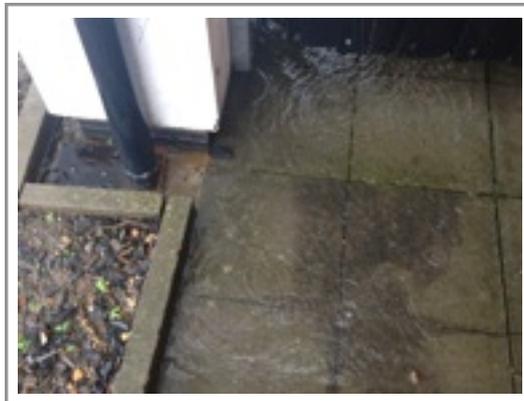
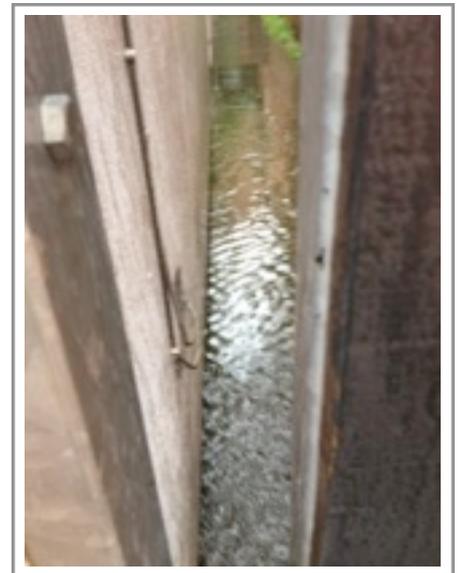
New service alley way between Wesley's and Foundation Foyer floods regularly and then fills Wesley's cellars and walls.

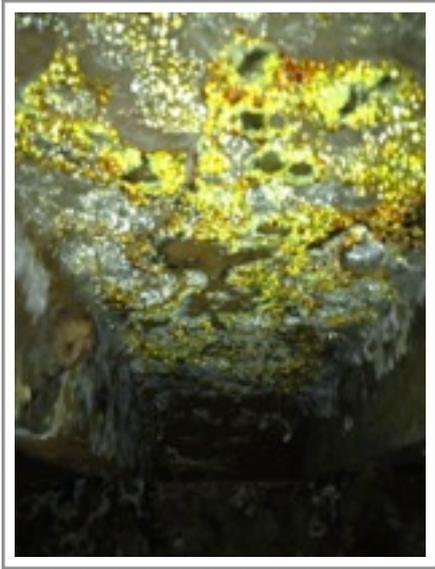
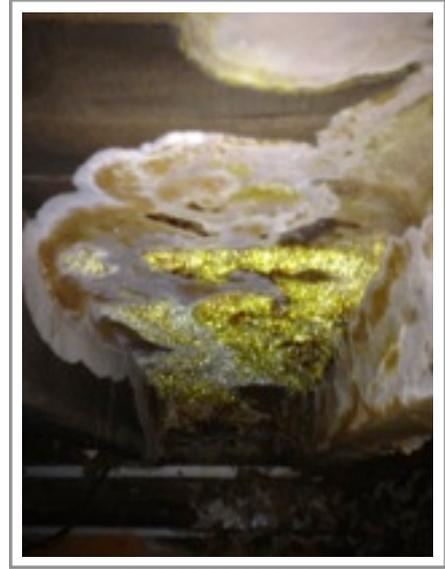
70 foot long cellars having been blocked off were full of dry rot across walls and floors at a disastrous level. One cellar being completely covered over every surface.

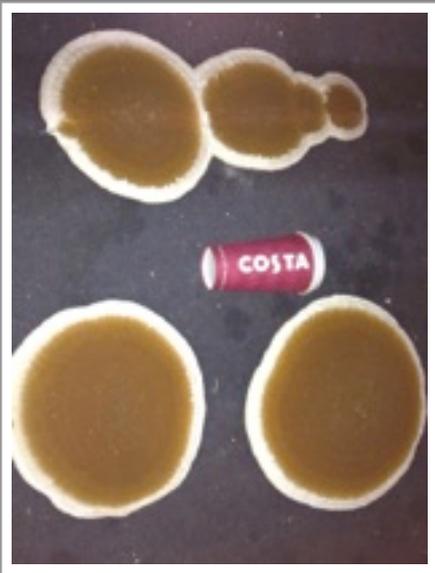
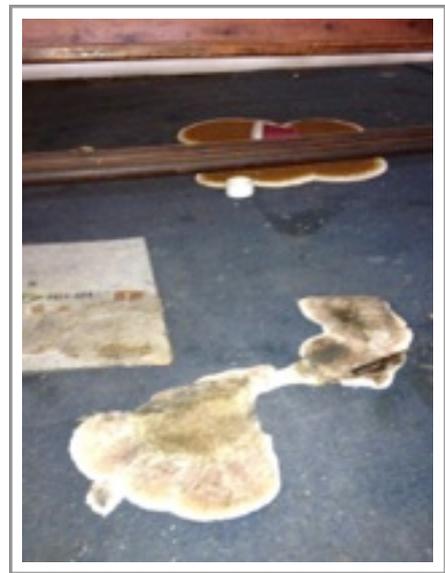
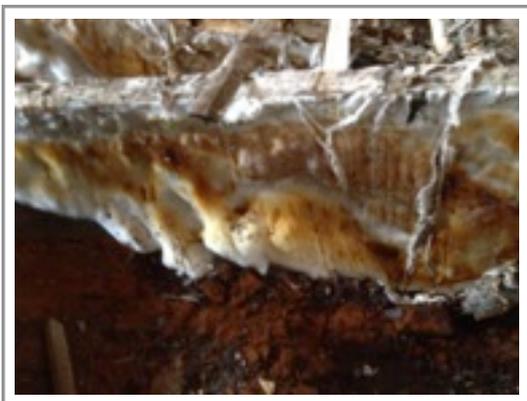
Main Hall Floors producing fresh dry rot spores in large 2ft. pancakes. Carpet tiles full of dry rot underneath.

- It SADLY has to change for the following reasons.....
- Dry Rot ravaged:** both Aquafoss & Rudders & Paynes have said the floor has to go as Dry Rot & other infestations have run riot and will keep coming back for up to 3 years etc. Also no Dry Rot Company will give a guarantee if it stays as the building can't achieve the 20% damp level due to all the other cellar & ground water level issues that have been present for most of its life. Dry Rot attacks are recorded for many decades and have never been defeated yet. So Block & Beam Floor, and Iron RSJs etc. in the cellar will survive further attacks, where as wood will not etc. We need to get serious with the floor to save the whole building from succumbing to DRY ROT in future as it is already half the way up the wall in places.

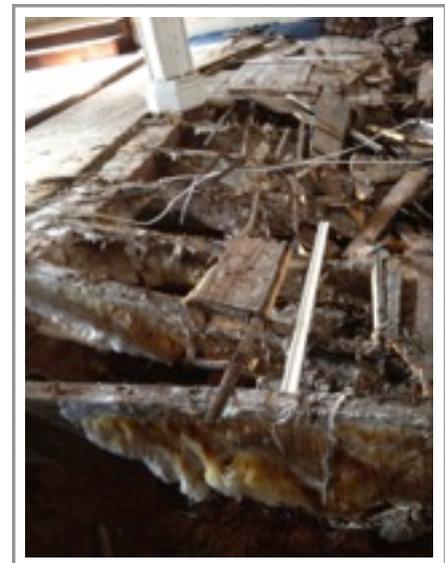
Beams & Floor Boards destroyed by rampant dry rot over large areas with floors collapsing & very dangerous

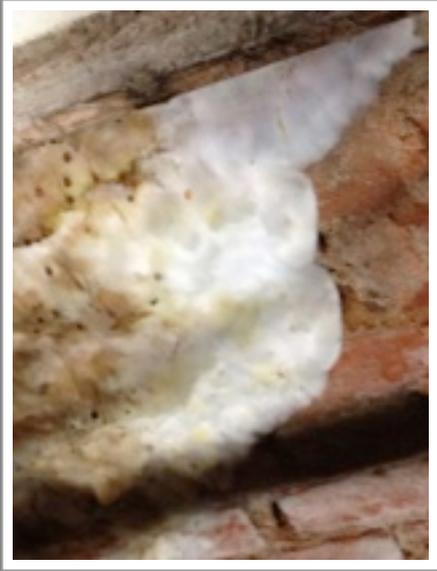
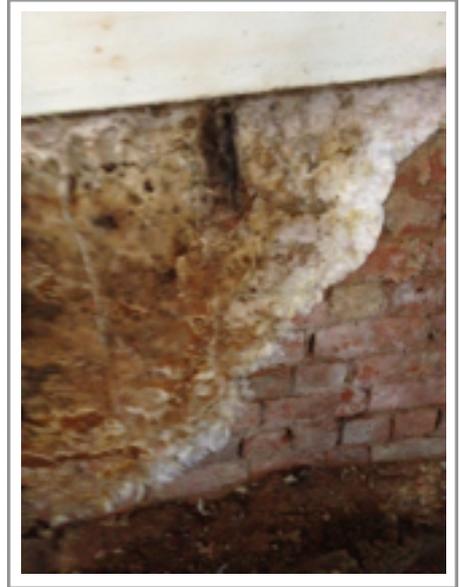
Walls substantially covered & infested with dry rot up to the window cills to date.

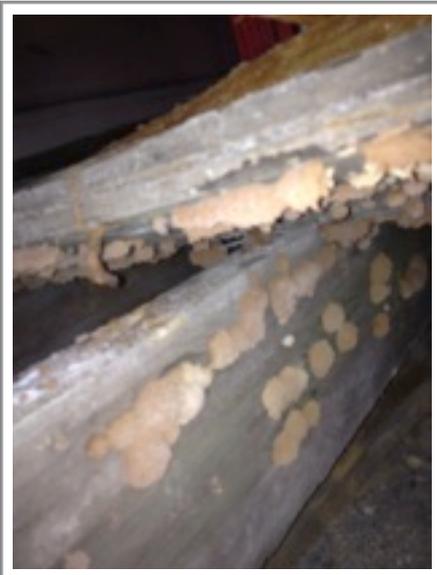
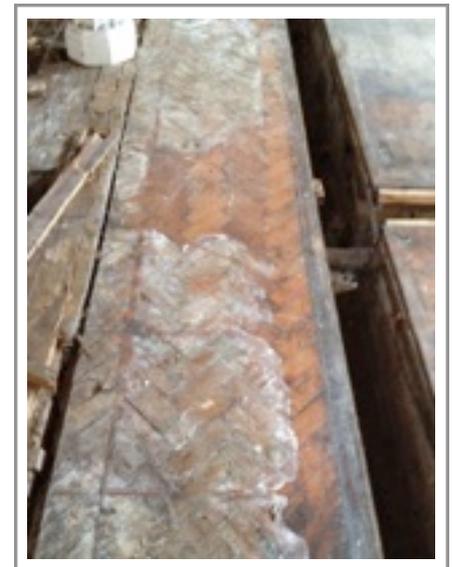
Serious Brown Rot infestation to main hall floors under balcony. Substantial Dry Rot infestation in woodblock floors & foundations

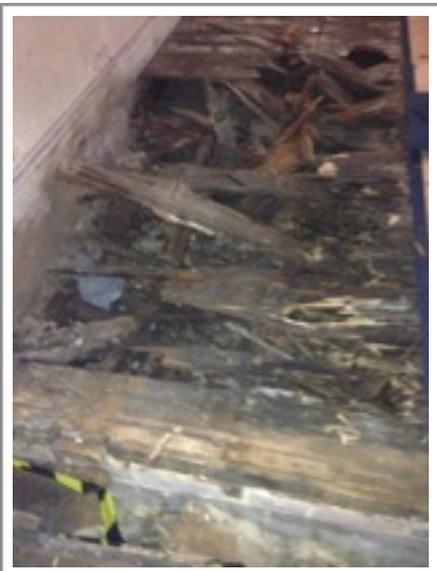
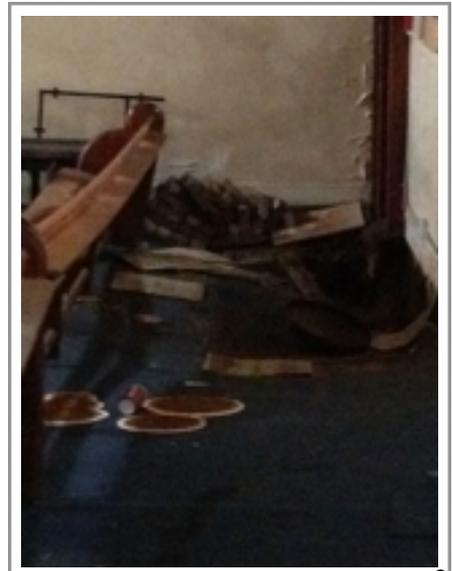
Large areas of floor collapse throughout main hall and all ground floor offices. Brown Rot collapse under balcony. Dry Rot collapse along left side of hall.

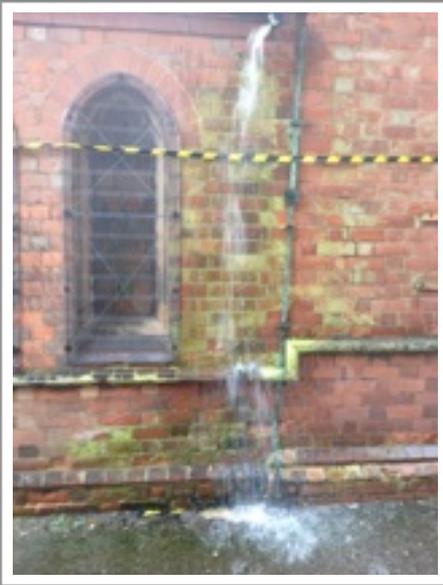
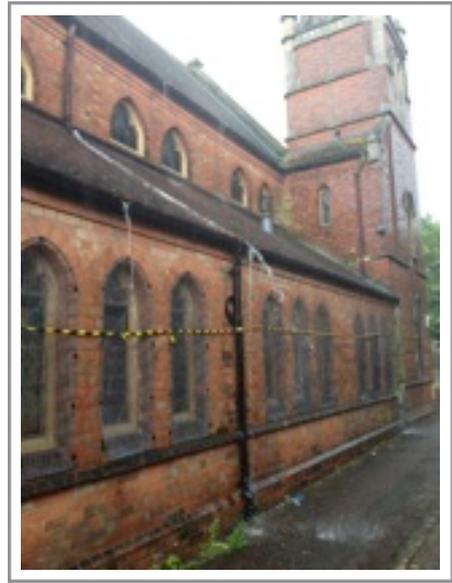
Broken & damaged guttering & downpipes of iron, plastic & asbestos.

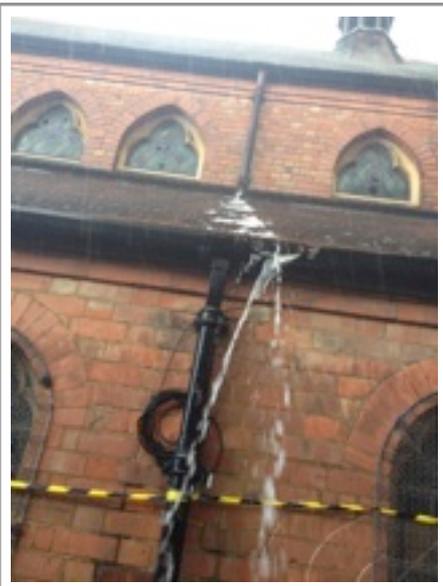
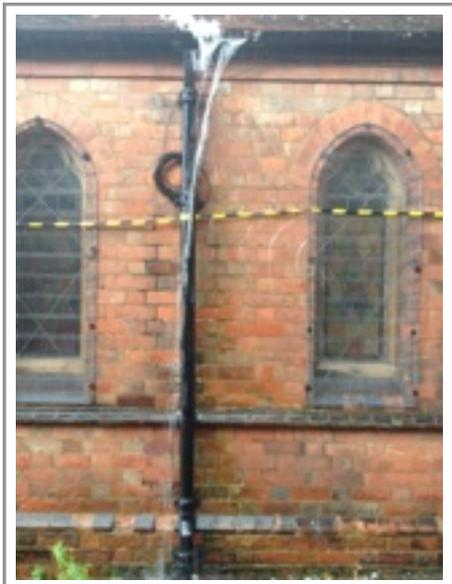
Gutters significantly blocked & wrong specification for the flow of water from these large roofs.

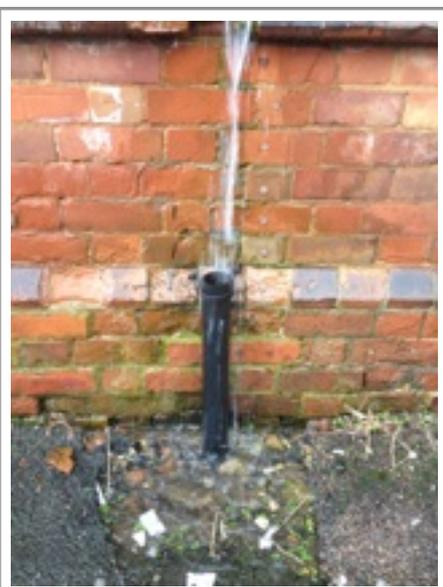
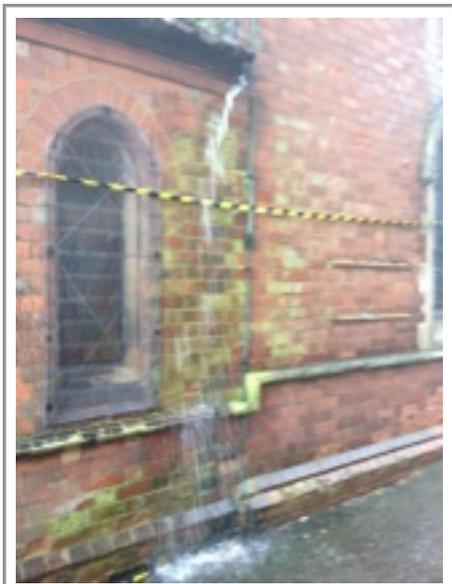
Ground level drains smashed & filled with concrete & tarmac in alley way. Water has no where to go but back in to Wesley's, which it has done for the past 30 years.

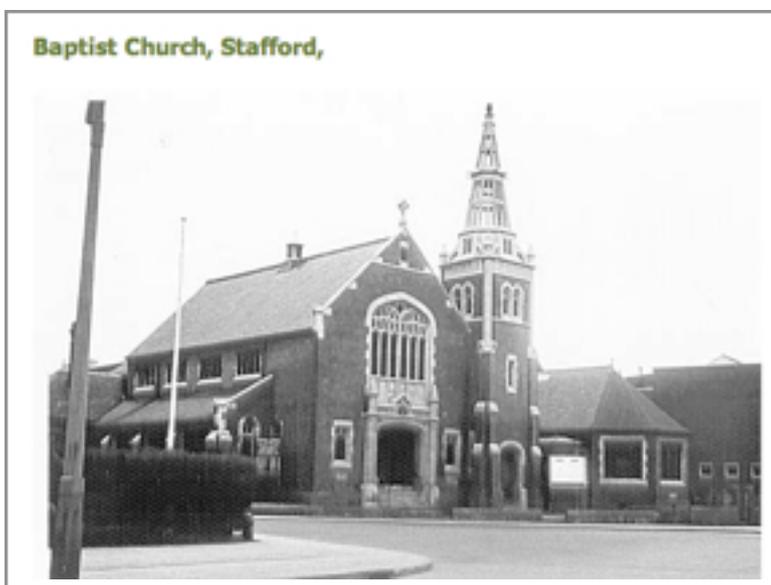
The unusual spire was designed by Birmingham Architect Ewen Harper, in 1896 following a previous successful similar design on Wesley's Methodist Church, Wolverton in 1892
